# **Everest Home**

# **Inspection Report**

123 Main St Anywhere, USA 55555

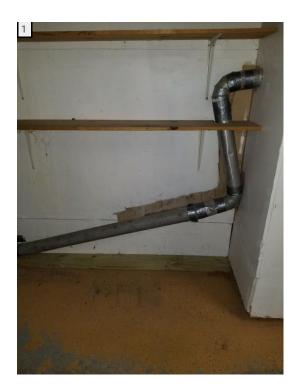
#### **Dryer venting is uninsulated**

**Location** Laundry Room / Mudroom

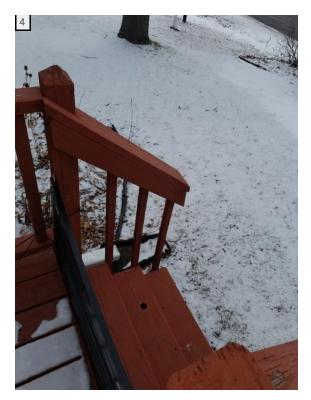
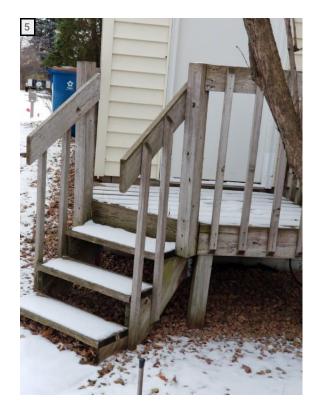
Gripable handrail is missing

**Location** Exterior: Ground View

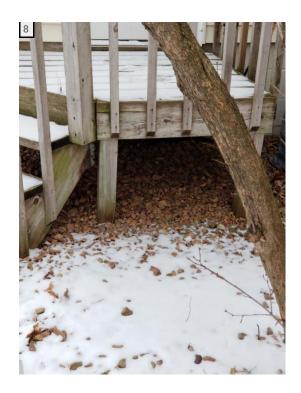
### Wood is in contact with soil

**Location** Exterior: Ground View

Impact The soil may cause moisture damage to the wood

Suggested Action Monitor for wood deterioration. Should deterioration happen have repaired

or replaced

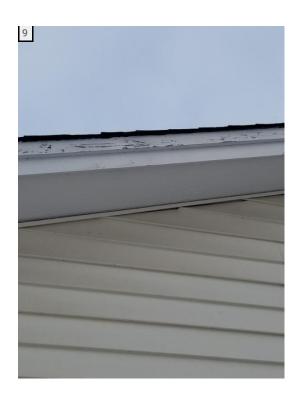
### Paint has peeled

**Location** Exterior: Ground View

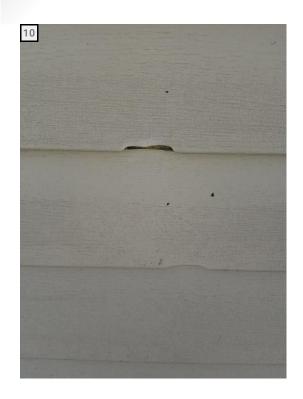
# **Siding is damaged**

**Location** Exterior: Ground View

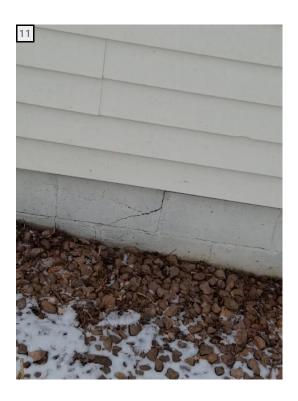
### **Exhibits hairline step cracking**

**Location** Exterior: Ground View

Impact The cracking may worsen allowing moisture intrusion

Suggested Action Monitor for further cracking. If the cracks widen have repaired by a

licensed waterproofing contractor

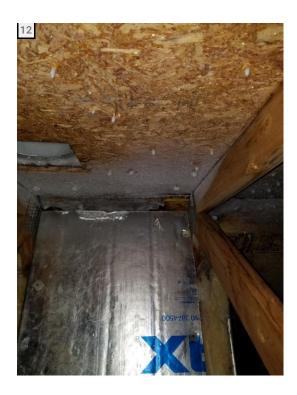
### Frost on roof sheathing

LocationAtticImpactExcess moisture in the garage with poor ventilation Suggested Action Reduce water leaking and consider adding attic vents

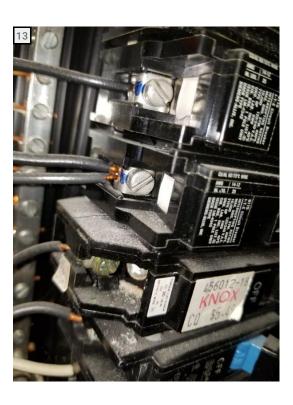
### Branch circuit is double tapped

**Location** Utility Room

Impact Excessive tripping may result and the circuit could need replacement more

often than rated, if breaker is not rated for 2 wires it could cause wires to

come loose

Other Information Double tapped means that two wires are connected to one circuit breaker.

This places a higher demand load on the circuit for which it is rated

Suggested Action Have repaired or replaced by a licensed electrician as needed

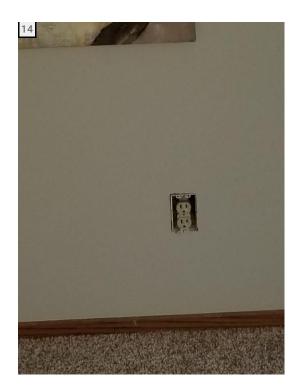
### Cover plate is missing

**Location** Living Room

Impact Without a cover plate, can cause electrical shock if touched

Suggested Action Install a cover

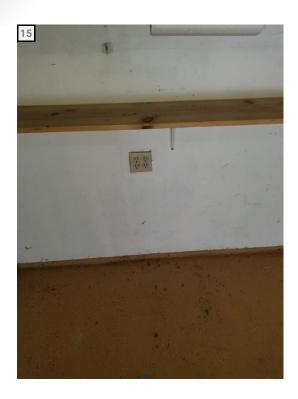
# **Not GFCI protected**

**Location** Attached Garage

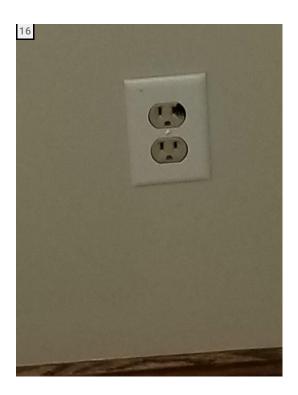
## **Outlet** is damaged

**Location** Master Bedroom

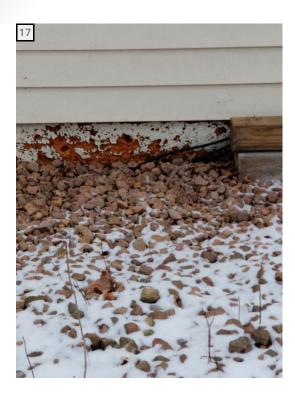
### **Exterior insulation is deteriorating**

**Location** Exterior: Ground View

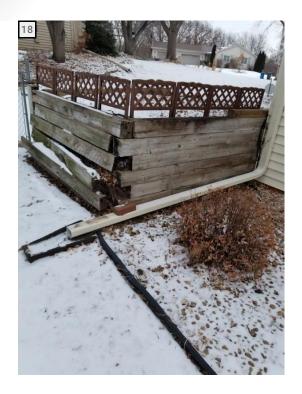
### **Falling apart**

**Location** Exterior: Ground View

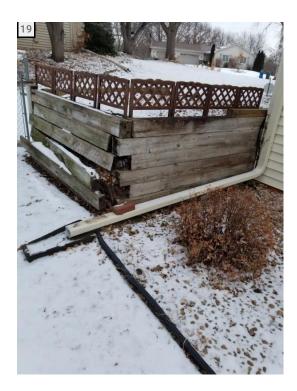
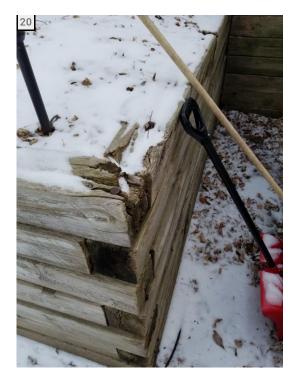
## **Wood is deteriorating**

**Location** Exterior: Ground View

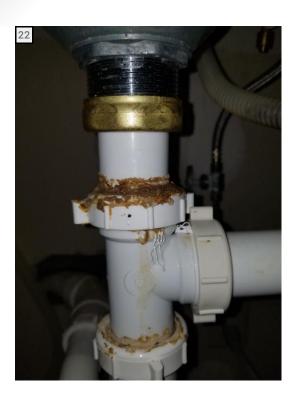
### Leaking

**Location** Kitchen, Laundry Room / Mudroom

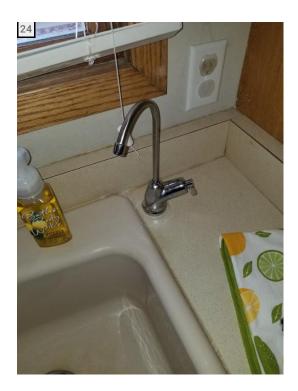
# **Drinking water faucet does not work**

**Location** Kitchen

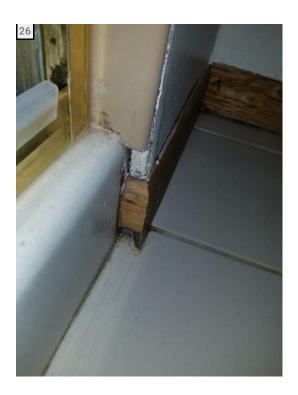
Sign water has leaked from shower surround

**Location** Lower Bathroom

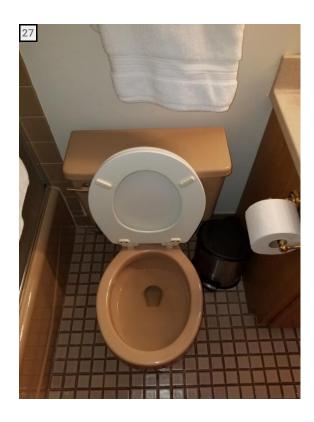
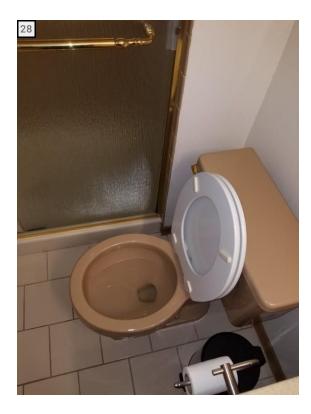
#### Loose

**Location** Lower Bathroom, Upper Bathroom Impact
Suggested Action
Estimated Repair Cost

A loose toilet may damage the wax ring that prevents leaking Remove toilet, replace the wax ring and re-install toilet

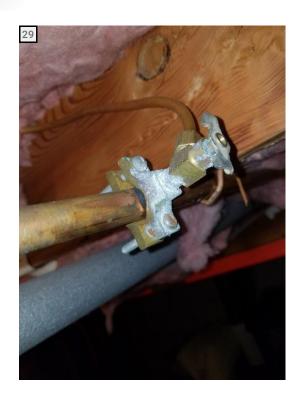
#### Saddle valve not code

**Location** Crawl Space **Suggested Action** Cap valve

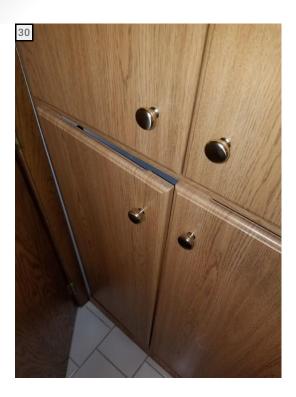
# **Door doesn't close completely**

**Location** Lower Bathroom

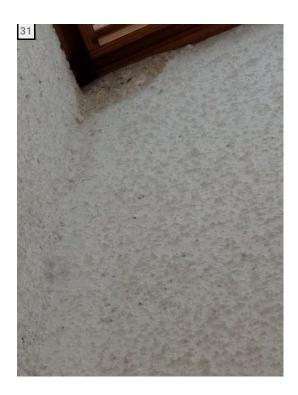
## **Ceiling has staining**

**Location** Upper Bathroom

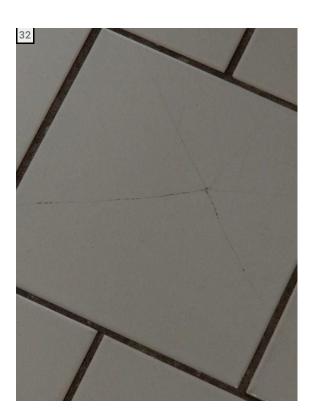
#### Tile is cracked

**Location** Kitchen

Impact The tiles could come loose and cause either a trip or a sharp edge cutting

hazard

Suggested Action Replace the broken tiles

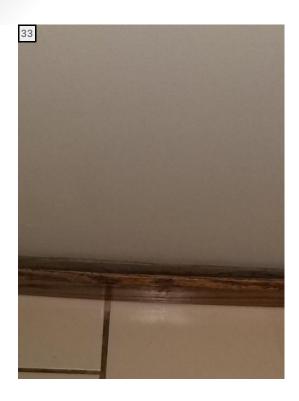
#### Loose

**Location** Laundry Room / Mudroom

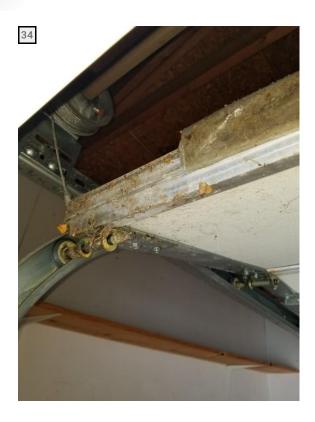
# Weather seal is damaged and/or missing

Location Attached Garage Estimated Repair Cost \$

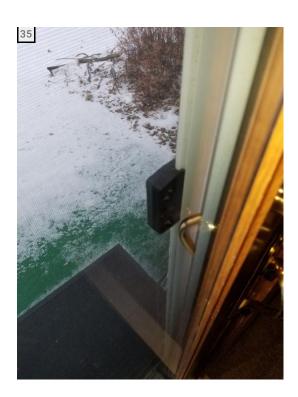
Screen door doesn't lock Location Family Room

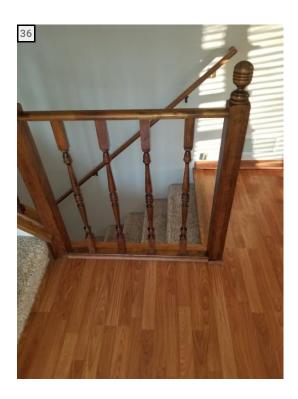
# Ballusters are spaced more than 4" apart

**Location** Hallway and Stairs

Impact Exposes a large gap through which a child may fall

Suggested Action Remove and replace the ballusters assuring 4" on center placement

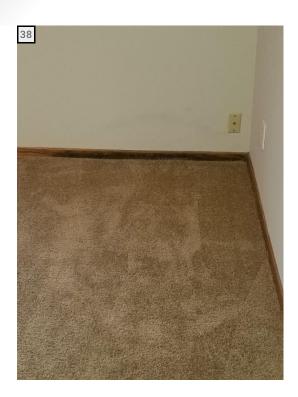
#### **Stain**

**Location** Family Room

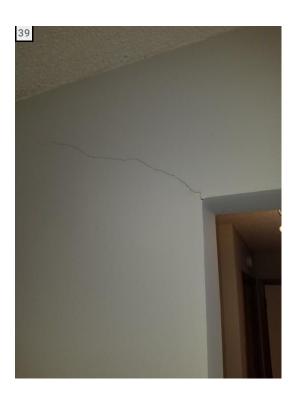
### **Drywall has settling cracks**

**Location** Kitchen

Suggested Action Repair with drywall tape and drywall compund and repaint

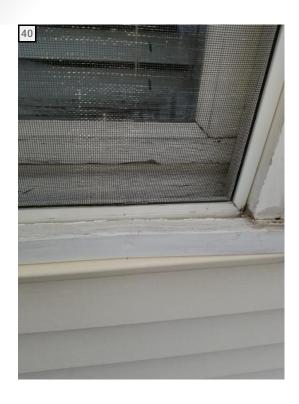
# Paint is peeling

**Location** Exterior: Ground View

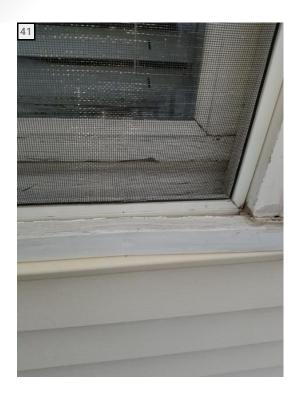
#### Sill is loose

**Location** Exterior: Ground View

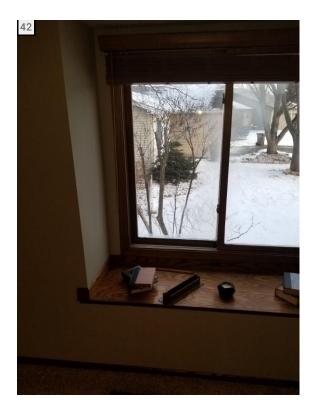
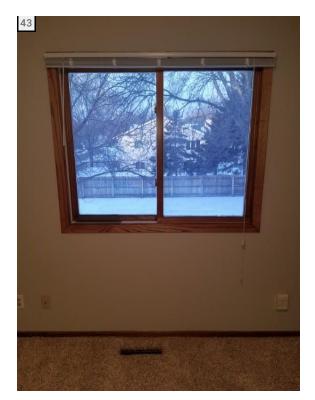
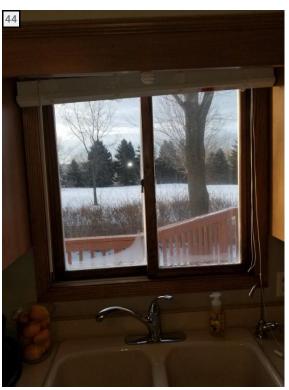
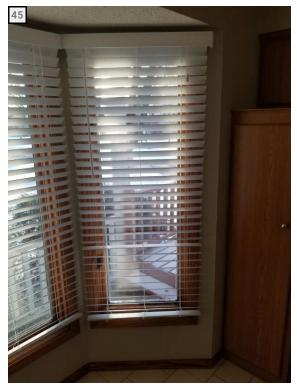
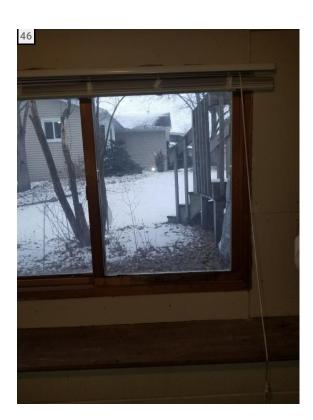
### Fogging or sweating

Location Master Bedroom, Kitchen, Upper Bedroom, Utility Room Should it worsen, insulating value may be impacted Monitor or replace to improve appearance

This is likely caused by a broken seal. Windows get their insulating value by trapping air between two well-sealed panes of glass. Some insulated windows are actually filled with argon gas which provides a higher insulating value. When the seals break, moist air enters the space. However, as long as there is minimal air movement in the space, the insulating value remains high. Broken seals are caused by buildup of water and other debris (pine needles, dust, etc.) in the window frame. Temperature differences between the indoors and outdoors also puts stress on the seals by causing them to expand and contract in cold weather
